**Peugeot 3008**  
Standard Safety Equipment

2016 ★★★★★

Tested Model	Peugeot 3008 1,6l Hdi Active
Body Type	- 5 door SUV
Year Of Publication	2016
Kerb Weight	1300kg
VIN From Which Rating Applies	- all 3008s
Class	Small Off-Road

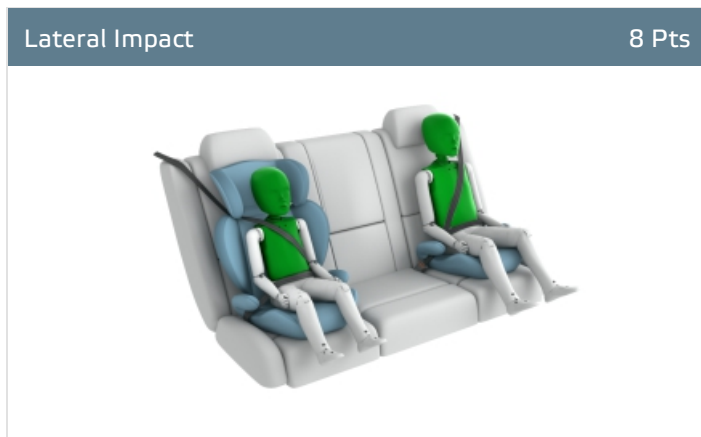
Crash Test Performance based on 6 & 10 year old children

Restraint for 6 year old child: *ROMER kidfix XP*  
 Restraint for 10 year old child: *GRACO Boster*

In the offset frontal impact, protection of the 10 year dummy's chest and neck was adequate and that of the head was good. Dummy readings of chest deceleration indicated marginal protection of the 6 year old's chest, with good protection of the head and neck. The 3008 provided good protection to all critical body areas of both dummies in the side barrier test. The front passenger airbag can be disabled to allow a rearward-facing child restraint to be used in that seating position. Clear information is provided regarding the status of the airbag and the system was rewarded. All of the child restraint types for which the 3008 is designed could be properly installed and accommodated in the vehicle.
