Tesla Model X
Standard Safety Equipment

2019

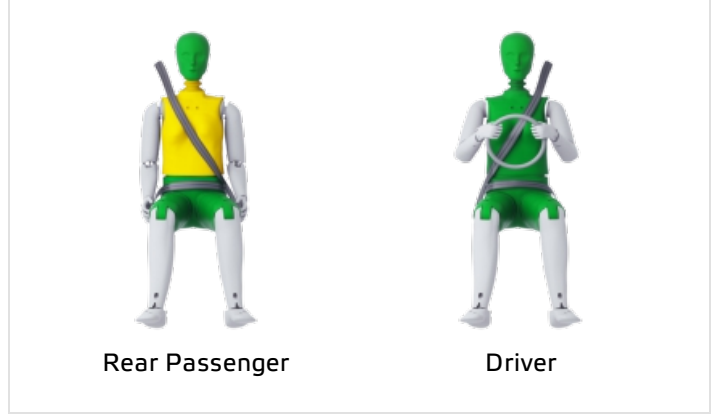
Frontal Full Width 7.8 / 8 Pts

Rear Passenger Driver

Detailed description: This panel shows two crash test dummies. The Rear Passenger dummy is wearing a yellow vest (Adequate) and is seated in a car seat. The Driver dummy is wearing a green vest (Good) and is seated in a car seat with a steering wheel. Both dummies are facing forward.

The passenger compartment of the Model X remained stable in the frontal offset test. Dummy readings indicated good protection of the knees and femurs of the driver and passenger. Tesla showed that a similar level of protection would be provided to occupants of different sizes and to those sitting in different positions. Protection was rated as good for all critical body areas for the driver. This was also the case in the the full-width rigid barrier test, and protection was good or adequate for the rear passenger. In both the side barrier and the more severe side pole tests, protection of all critical body areas was good and the car scored full points in both of these tests. Tests on the front seats and head restraints demonstrated good protection against whiplash injuries in the event of a rear-end collision. A geometric assessment of the rear seats also indicated good whiplash protection. The standard-fit autonomous emergency braking (AEB) system performed well in tests of its functionality at the low speeds at which many whiplash injuries occur, with collisions avoided in all test scenarios.

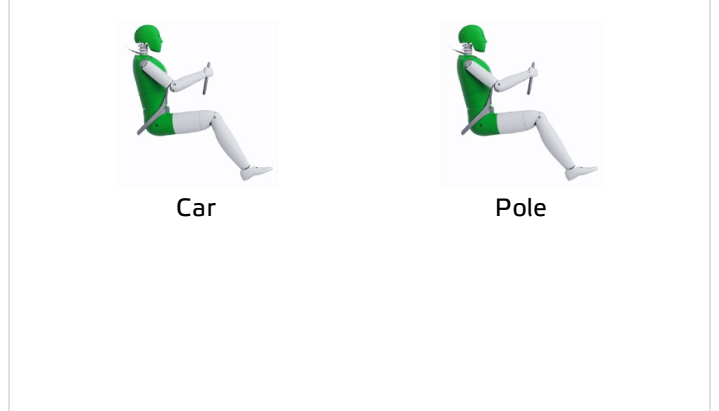
Lateral Impact 16 / 16 Pts

Car Pole

Detailed description: This panel shows two crash test dummies from a side perspective. The Car dummy is wearing a green vest (Good) and is seated in a car seat. The Pole dummy is wearing a green vest (Good) and is seated in a car seat. Both dummies are facing forward.

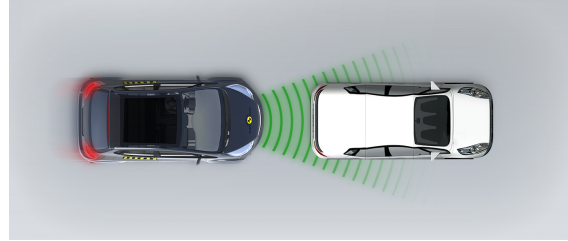
Approaching a stationary car: No Offset

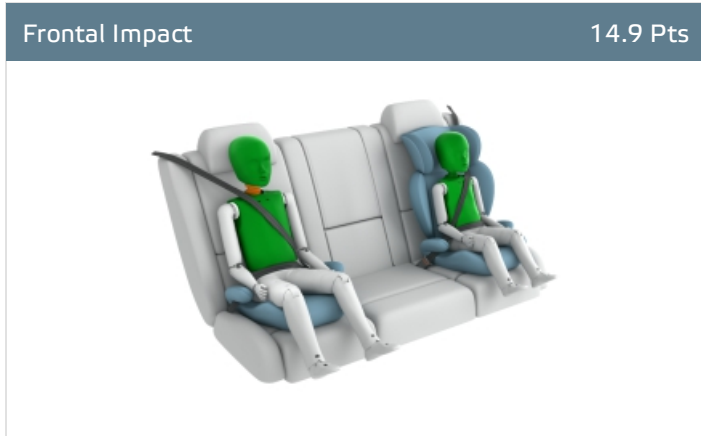
Crash Test Performance based on 6 & 10 year old children

22.9 / 24 Pts

Restraint for 6 year old child: *Britax Römer KidFix²*
 Restraint for 10 year old child: *Booster Cushion*

In the frontal offset test, protection of the neck of the 10 year dummy was marginal, based on readings of neck forces. Otherwise, in both the frontal and side barrier tests, protection of all critical body areas was good for both dummies. The front passenger airbag can be disabled to allow a rearward-facing child restraint to be used in that seating position. Clear information is provided to the driver regarding the status of the airbag and the system was rewarded. There is not enough room to install a universal child restraint in the optional third row seats and to use the second row seats in their normal positions. Accordingly, the restraint installation test was failed for the third row seats. Otherwise, the restraints for which the Model X is designed could be properly installed and accommodated in the car.

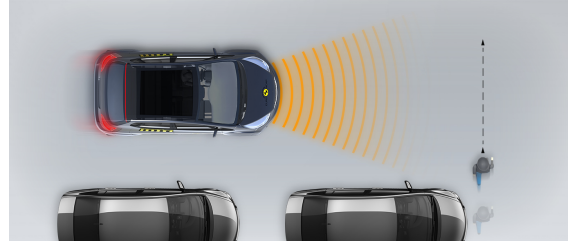
Child running from behind parked vehicles

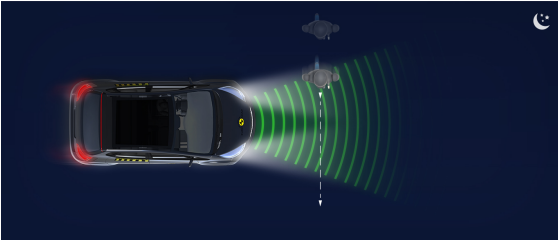
Adult crossing the road

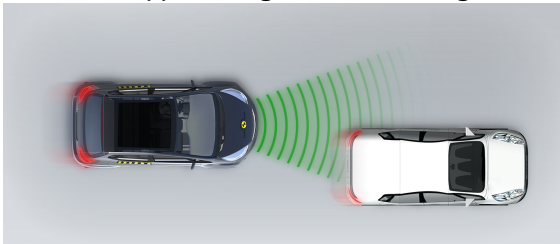
Approaching a slower moving car

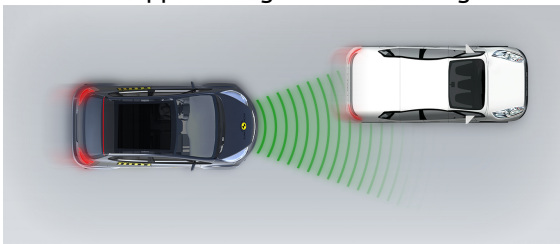
Approaching a slower moving car

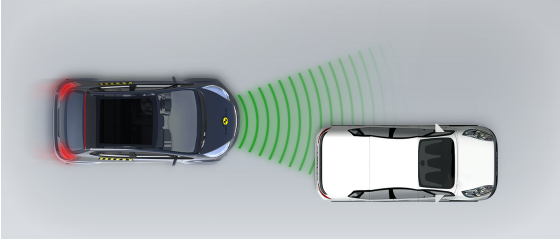
Approaching a stationary car

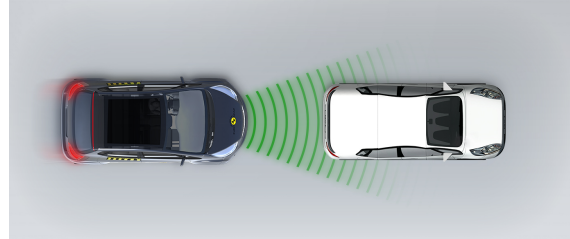
Approaching a stationary car

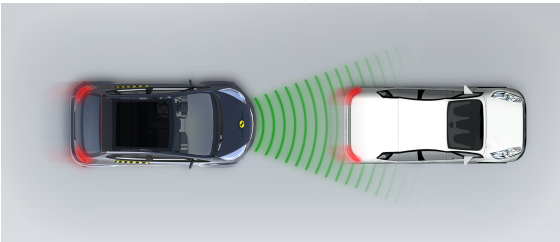
Approaching a braking car
