Dacia Sandero Stepway
Standard Safety Equipment

2021

Tested Model	Dacia Sandero Stepway 1.0TCe, LHD
Body Type	- 5 door hatchback
Year Of Publication	2021
Kerb Weight	1111kg
VIN From Which Rating Applies	- all Sanderos and Sandero Stepways
Class	Supermini

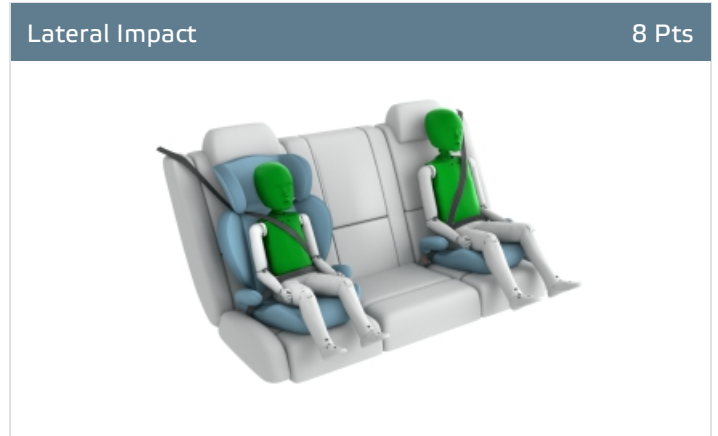
Crash Test Performance based on 6 & 10 year old children

18.6 / 24 Pts

Restraint for 6 year old child: *Britax Römer KidFix XP*
 Restraint for 10 year old child: *Britax Römer KidFix XP (Booster only)*

In the frontal offset test, protection of the chest and neck of the 10 year dummy was rated as weak, based on dummy readings during the impact. For the 6 year dummy, protection of the neck was marginal while that of the head and chest was adequate and good respectively. The front passenger airbag can be disabled to allow a rearward-facing child restraint to be used in that seating position. Clear information is provided to the driver regarding the status of the airbag and the system was rewarded. All of the child restraints for which the Sandero Stepway is designed could be properly installed and accommodated. One, a full sized rearward facing toddler restraint, could be fitted in the car with no problem but was deemed a fail because Dacia indicate in the user manual that the car cannot accommodate this (R3) category of restraint.

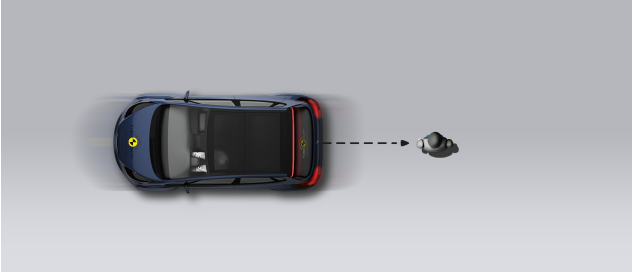
Vehicle reversing into standing pedestrian

The protection provided by the bonnet to the head of a struck pedestrian was predominantly good or adequate with poor results recorded at the base of the windscreen and on the stiff windscreen pillars. The bumper provided good or adequate protection to pedestrians' legs at all test locations. However, protection of the pelvis was poor over much of the width of the car. The autonomous emergency braking (AEB) system of the Sandero Stepway does not detect vulnerable road users such as pedestrians and cyclists.

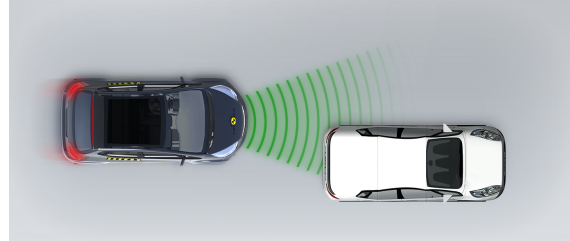
Approaching a stationary car

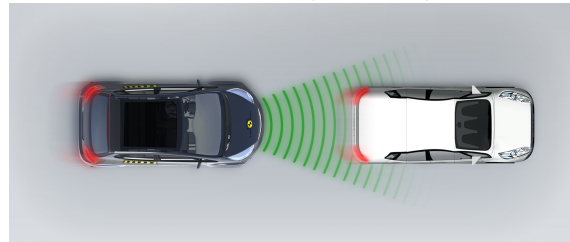
Approaching a braking car
