**Kia Sportage**  
Small Off-Road

2015 ★★★★★

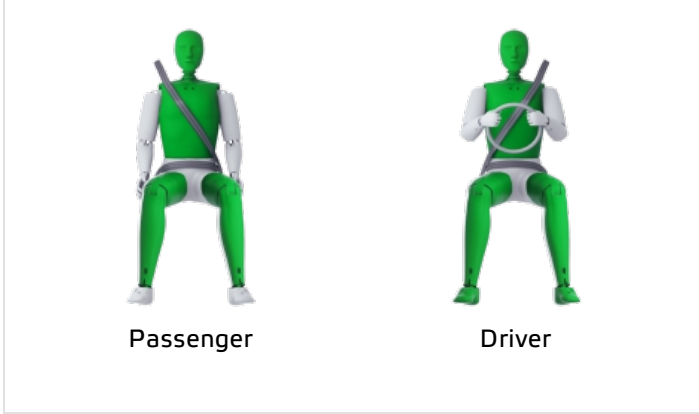
Frontal Offset Deformable Barrier 8 Pts

Passenger                      Driver

Detailed description: This panel shows two crash test dummies, one for the passenger and one for the driver, seated in a car. Both dummies are colored green, indicating a 'GOOD' performance. The passenger dummy is on the left, and the driver dummy is on the right. They are both wearing seatbelts. The background is white.

The Sportage scored maximum points in the frontal offset test, with good protection of all critical body areas for both the driver and passenger dummies. Dummy readings indicated good protection of the knees and femurs of both dummies and Kia showed that a similar level of protection would be provided to occupants of different sizes and to those sat in different positions. In the full-width rigid barrier test, protection of the driver and rear passenger was good for all body areas except the chest, protection of which was adequate for both, with only a fraction of a point being lost for the driver. In the side barrier impact, protection of all critical parts of the body was again good, and the Sportage scored maximum points. Even in the more severe side pole test, all body areas were well protected. The front seats and head restraints demonstrated good protection against whiplash injury in Euro NCAP's tests. A geometric assessment of the rear seats indicated marginal whiplash protection for the occupants of those seats. An autonomous emergency braking system is available on the Sportage which would provide additional whiplash protection at the low, city speeds at which such injuries commonly occur. The system was not included in this assessment as it is not standard equipment.

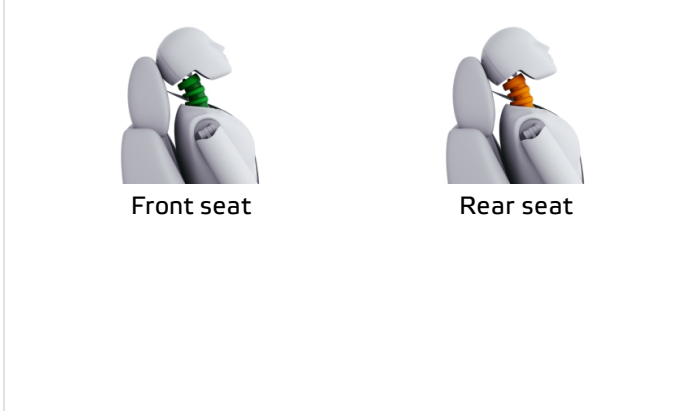
Whiplash Rear Impact 2.3 Pts

Front seat                      Rear seat

Detailed description: This panel shows two crash test dummies seated in a car, illustrating whiplash rear impact. The dummy on the left is on the front seat and has a green spine, indicating a 'GOOD' performance. The dummy on the right is on the rear seat and has an orange spine, indicating a 'MARGINAL' performance. The background is white.

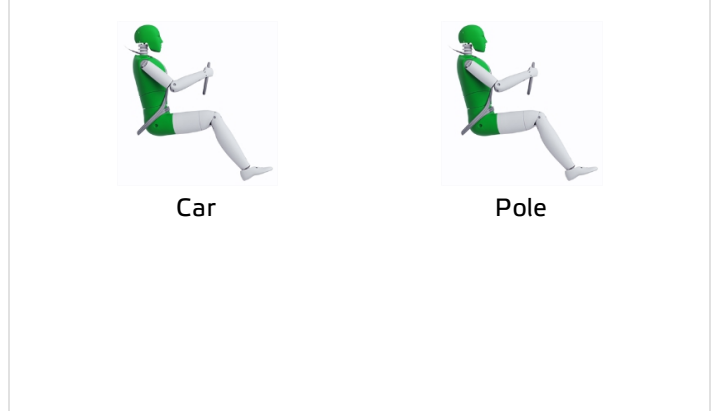
Lateral Impact 16 Pts

Car                      Pole

Detailed description: This panel shows two crash test dummies seated in a car, illustrating lateral impact. The dummy on the left is on the car and has a green spine, indicating a 'GOOD' performance. The dummy on the right is on the pole and has a green spine, indicating a 'GOOD' performance. The background is white.
