Mercedes Benz CITAN Kombi

TEST 2013 ★★☆☆☆

Mercedes-Benz CITAN Kombi, 109 Blue Efficiency 'High' grade

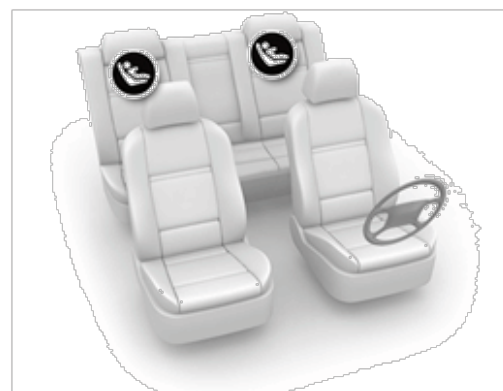
Attacco Isofix

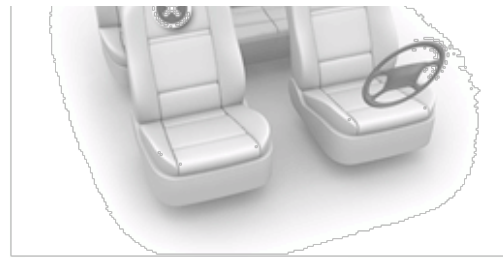
CRS INSTALLATION CHECK 7.1 punti

Installazione senza problemi

Installazione accurata

Problema per la sicurezza

Installazione non consentita

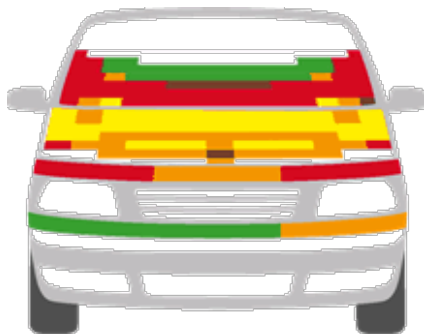
Totale 20 punti | 56%

TESTA 14.0 punti

BACINO 0.5 punti

GAMBA 5.9 punti

The bumper was predominantly good but the front edge of the bonnet provided poor protection in most of the areas tested. Adequate protection was provided by the bonnet over much of its surface but protection in those areas where an adult's head might strike was mostly poor.
