## Citroën Berlingo

Standard Safety Equipment

2018

Tested Model	Peugeot Rifter BlueHDi 100 Allure, LHD
Body Type	- 5 door MPV
Year Of Publication	2018
Kerb Weight	1510kg
VIN From Which Rating Applies	- all Berlingos
Class	Small MPV

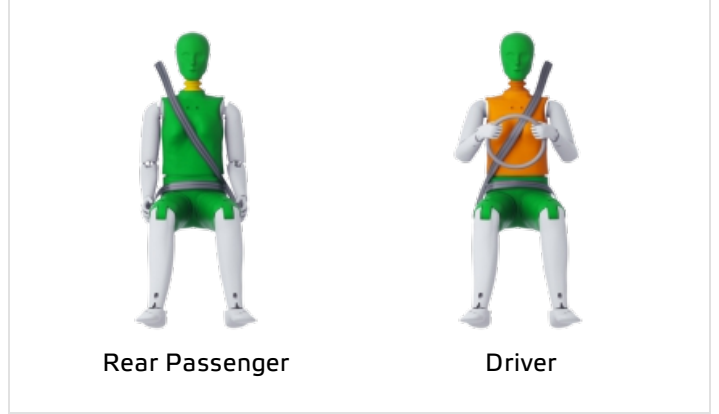
Frontal Full Width 7.2 / 8 Pts

Rear Passenger                      Driver

Detailed description: This panel shows two crash test dummies seated in a car. The dummy on the left is labeled 'Rear Passenger' and is wearing a green vest and green pants. The dummy on the right is labeled 'Driver' and is wearing an orange vest and green pants. Both dummies are secured with seatbelts. The background is white.

The passenger compartment remained stable in the frontal offset test. Dummy readings showed good protection for the knees and femurs of both the driver and passenger. It was demonstrated that a similar level of protection would be provided to occupants of different sizes and to those sitting in different positions. In the full-width rigid barrier test, protection of the driver dummy was marginal for the chest and neck and good for other critical body areas. Protection of the rear passenger was good or adequate. In the side barrier test, protection of all critical body areas was good and the car scored maximum points. Even in the more severe side pole impact, protection of the chest was adequate and that of other critical body areas was good. Tests on the front seats and head restraints demonstrated good protection against whiplash injury in the event of a rear-end collision. A geometric assessment of the rear seats also indicated good whiplash protection. The standard-fit autonomous emergency braking (AEB) system performed well in tests of its functionality at the low speeds, typical of city driving, at which many whiplash injuries are caused.

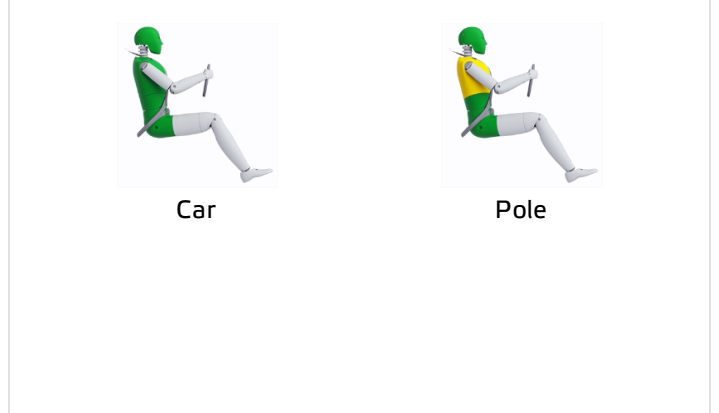
Lateral Impact 15.6 / 16 Pts

Car                      Pole

Detailed description: This panel shows two crash test dummies seated in a car. The dummy on the left is labeled 'Car' and is wearing a green vest and green pants. The dummy on the right is labeled 'Pole' and is wearing a yellow vest and green pants. Both dummies are secured with seatbelts. The background is white.

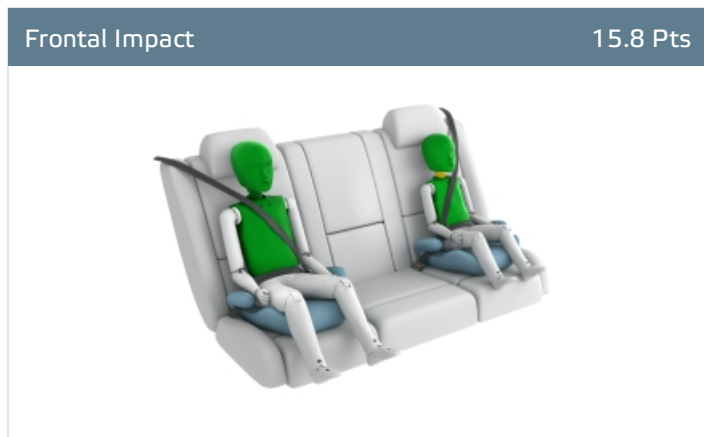
Crash Test Performance based on 6 & 10 year old children

23.8 / 24 Pts

Restraint for 6 year old child: *Britax Römer KidFix XP*  
 Restraint for 10 year old child: *Graco Booster*

With the exception of the neck of the 6 year dummy, protection of which was adequate, dummy results in both the frontal offset and the side barrier impacts showed good protection for all critical body areas for the 6 and 10 year children. The front passenger airbag can be deactivated to allow a rearward-facing child restraint to be used in that seating position. Clear information is provided to the driver regarding the status of the airbag and the system was rewarded. All of the restraint types for which the vehicle is designed could be properly installed and accommodated in the car. However, ISOFIX/i-Size anchorages are optional in the second-row centre seating position in some countries and buyers should ensure they order these if they are needed. The optional third row seats are not suitable for child restraints.
