**Kia Picanto**  
Standard Safety Equipment

2017

Tested Model	Kia Picanto 1.0 GLS, LHD
Body Type	- 5 door hatchback
Year Of Publication	2017
Kerb Weight	899kg
VIN From Which Rating Applies	- all Picantos
Class	Supermini

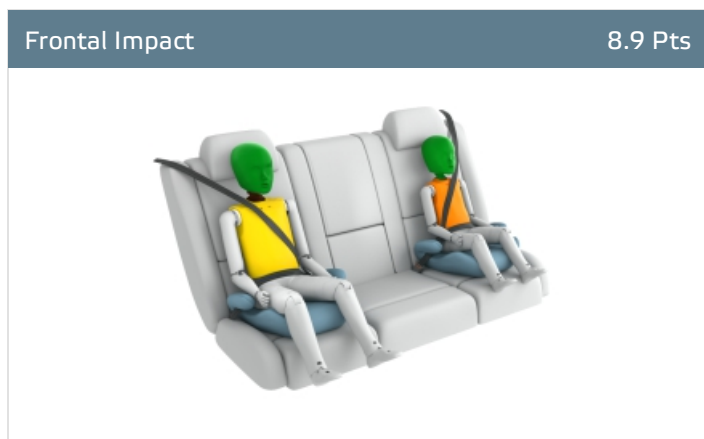
Crash Test Performance based on 6 & 10 year old children

Restraint for 6 year old child: *Römer KidFix II XP*  
 Restraint for 10 year old child: *Graco Junior III*

In the frontal offset test, dummy readings of neck tension indicated weak protection of this part of the body for the 10 year dummy. Chest protection for the 6 year dummy was rated as marginal. In the side barrier test, protection of the 6 year dummy was good. However, protection of the chest was poor for the 10 year dummy, sat on the struck side of the car and the head made contact with the vehicle interior. The front passenger airbag can be disabled to allow a rearward-facing child restraint to be used in that seating position. Clear information is provided to the driver regarding the status of the airbag and the system was rewarded. The rear centre seat cannot accommodate universal child restraints which make use of the seatbelt. Otherwise, restraints could be properly installed and accommodated by the car.
