SsangYong Korando
Standard Safety Equipment

2019

Tested Model	SsangYong Korando 1.6 diesel, LHD
Body Type	- 5 door SUV
Year Of Publication	2019
Kerb Weight	1728kg
VIN From Which Rating Applies	- all Korandos
Class	Small Family Car

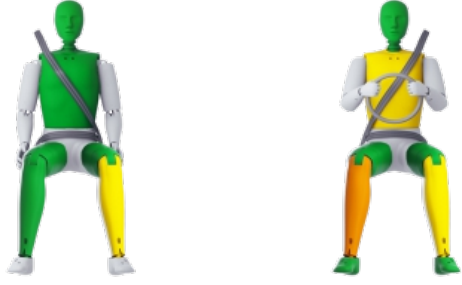
Frontal Offset Deformable Barrier 6.9 / 8 Pts

Passenger Driver

The passenger compartment of the Korando remained stable in the frontal offset test. Dummy readings indicated good protection of the knees and femurs for both driver and passenger. SsangYong showed that a similar level of protection would be provided to occupants of different sizes and to those sitting in different positions. In the full-width rigid barrier test, protection of the driver dummy was good or adequate. For the rear dummy, readings indicated a drop in the iliac force, indicating that the pelvis had slipped underneath the lap section of the seatbelt, a phenomenon known as 'submarining'. Although dummy readings did not indicate a high risk of injury, the car was penalised and protection of the pelvis rated as poor. In the side barrier test, protection of all critical body areas was good and the Korando scored maximum points. In the more severe side pole impact, dummy readings of rib deflection indicated marginal protection of the chest, while that of other critical body areas was good. Tests on the front seats and head restraints demonstrated good protection against whiplash injuries in the event of a rear-end collision. A geometric assessment of the rear seats indicated marginal whiplash protection. The standard-fit autonomous emergency braking (AEB) system scored maximum points in tests of its functionality at the low speeds at which many whiplash injuries occur, with car-to-car collisions avoided in all test scenarios.

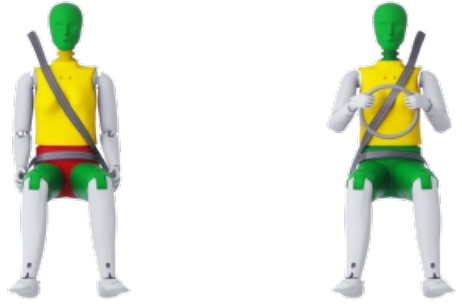
Frontal Full Width 6.4 / 8 Pts

Rear Passenger Driver

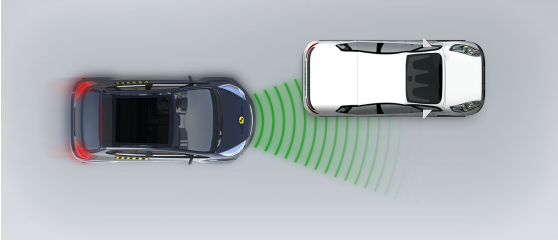
Approaching a stationary car: Left Offset

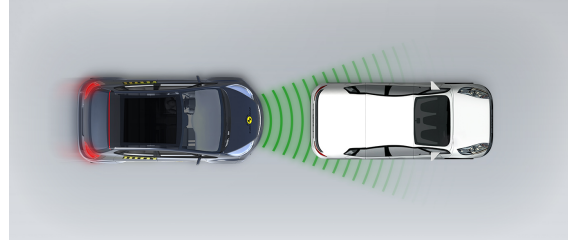
Approaching a stationary car: No Offset

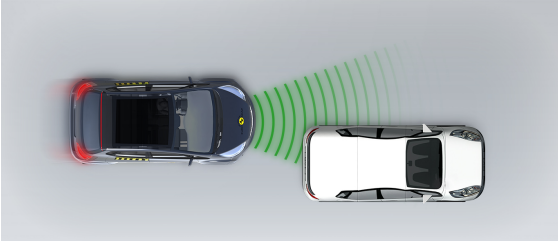
Approaching a stationary car: Right Offset

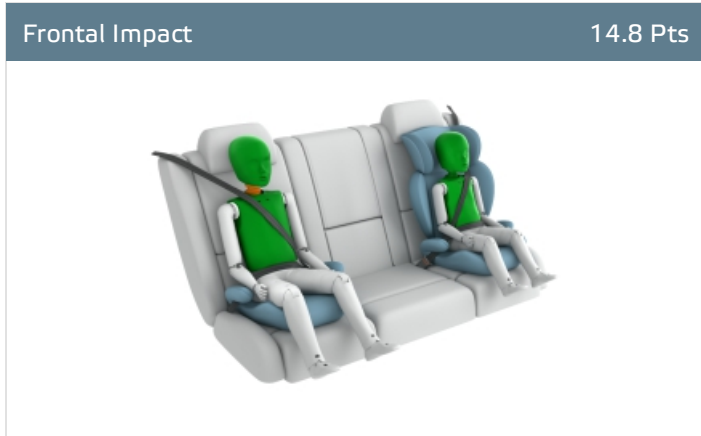
22.8 / 24 Pts

Crash Test Performance based on 6 & 10 year old children

Restraint for 6 year old child: *Britax Römer KIDFIX II XP SICT*
 Restraint for 10 year old child: *Booster Cushion*

In the frontal offset test, protection of the six-year dummy was good for all critical body areas. For the ten-year-old, dummy readings of neck tension indicated marginal protection for this body region, but protection elsewhere was good. In the side barrier test, protection of all critical parts of the body was good for both child dummies. The front passenger airbag can be disabled to allow a rearward-facing child restraint to be used in that seating position. Clear information is provided to the driver regarding the status of the airbag and the system was rewarded. All restraint types for which the Korando is designed could be properly installed and accommodated in the car.

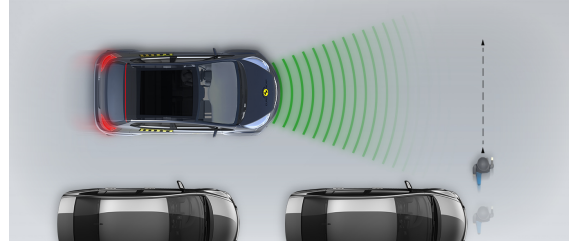
Child running from behind parked vehicles

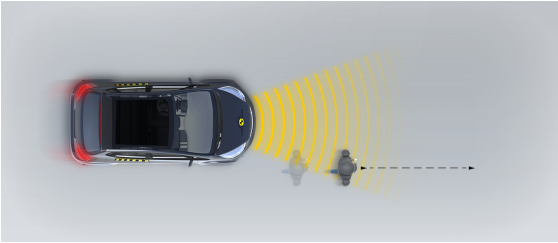
Adult along the roadside

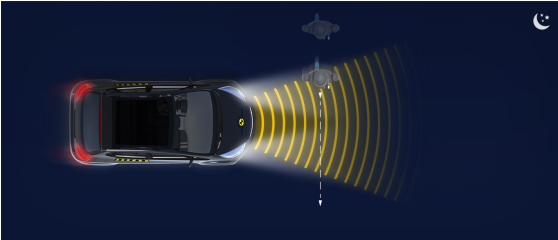
Adult crossing the road

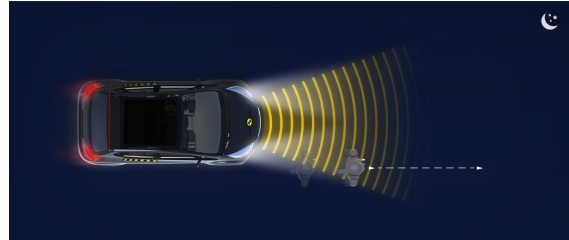
Adult along the roadside

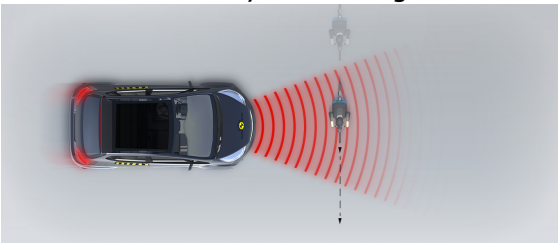
Cyclist crossing

The protection provided to the head of a struck pedestrian was good or adequate over most of the bonnet surface, with poor results recorded at the base of the windscreen and on the stiff windscreen pillars. Protection of pedestrians' legs was good at all test locations but protection of the pelvis was mixed. The AEB system of the Korando can detect vulnerable road users like pedestrians and cyclists, as well as other vehicles. In tests of its response to pedestrians, the system performed adequately. The system's reaction to cyclists was rated as marginal.

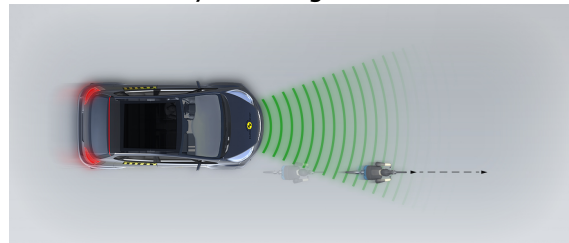
Cyclist along the roadside

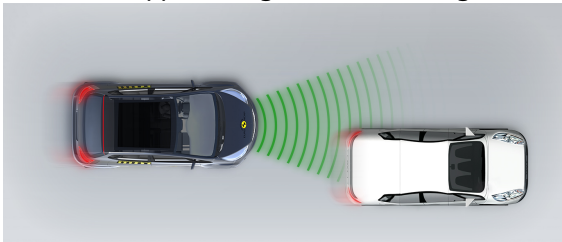
Approaching a slower moving car

The AEB system performed well in tests of its response to other vehicles at highway speeds, with collisions avoided in almost all test scenarios. A seatbelt reminder system is standard for the front and rear seats. A camera-based speed limit recognition system presents the information the driver, allowing the speed limiter to be set appropriately. The lane support system helps to prevent inadvertent drifting out of lane and also intervenes more aggressively in certain critical situations.

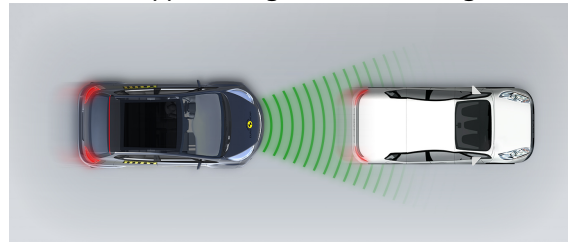
Approaching a slower moving car

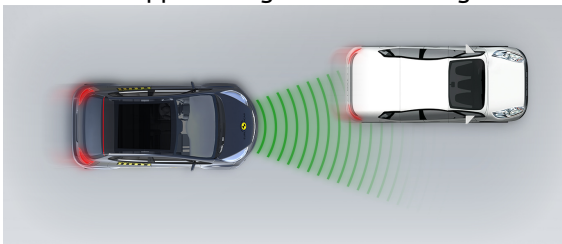
Approaching a slower moving car

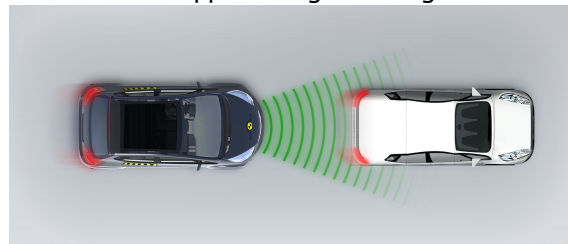
Approaching a braking car

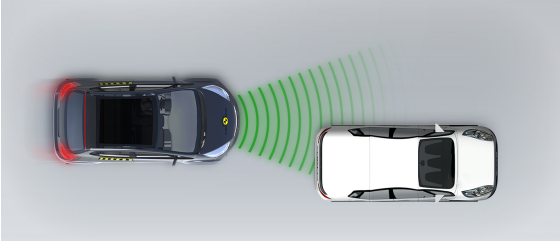
Approaching a stationary car

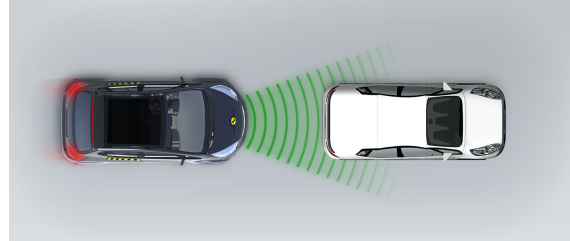
Approaching a stationary car

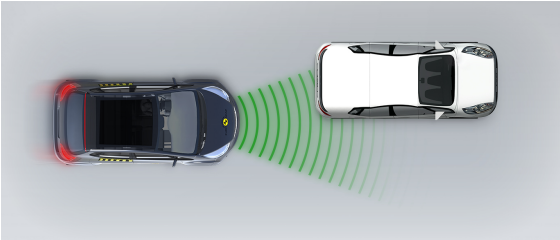
Approaching a stationary car

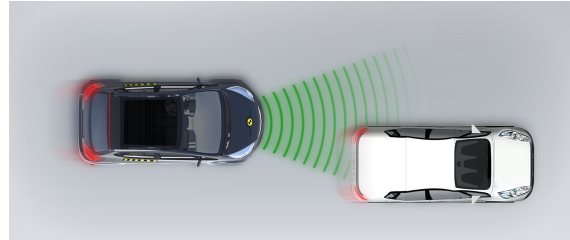
Approaching a slower moving car

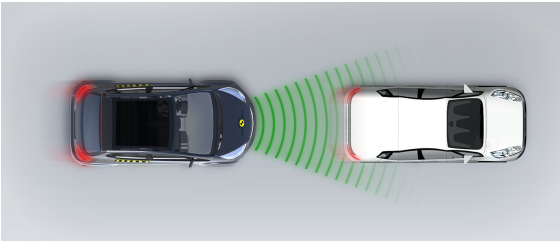
Approaching a slower moving car

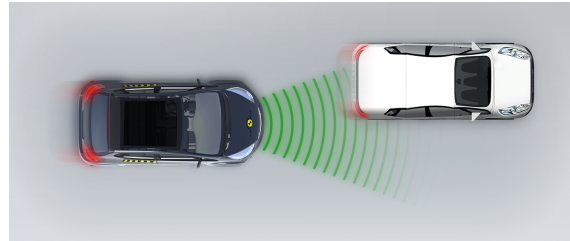
Approaching a slower moving car

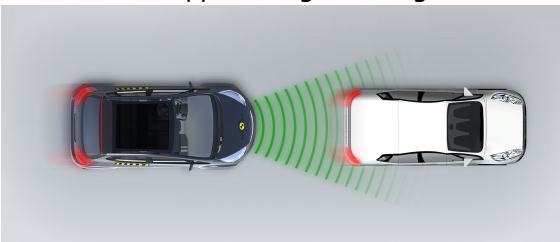
Approaching a braking car
