## Ford Kuga

Standard Safety Equipment

2019

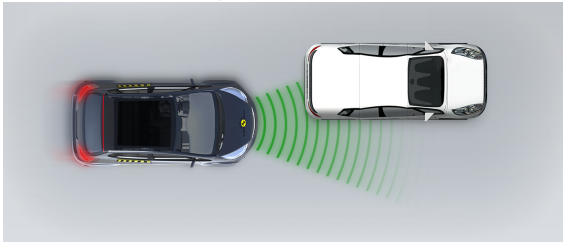
Approaching a stationary car: Left Offset

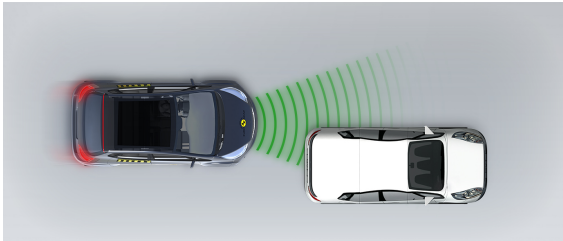
Approaching a stationary car: Right Offset

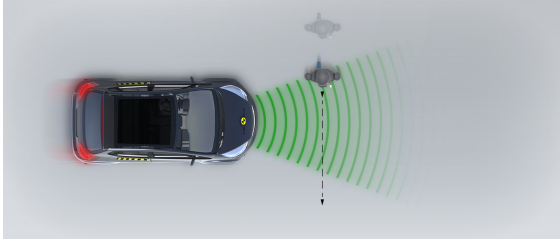
Adult crossing the road

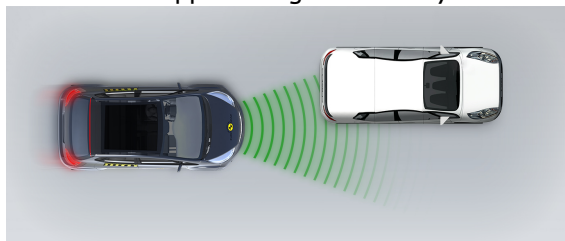
Approaching a stationary car

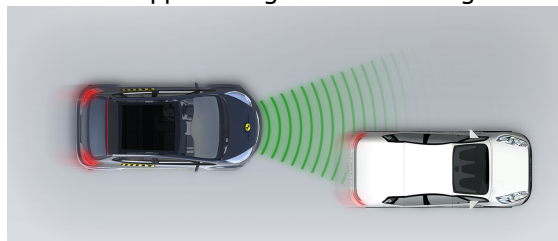
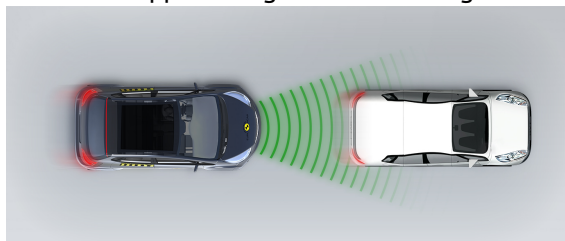
Approaching a slower moving car

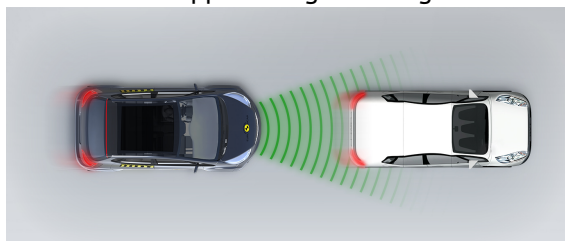
Approaching a braking car
